Case History

Rainbow provides drying solution for problem floor

The injection drying system was recently used by Rainbow International's branch in Ross-on-Wye following a flood and subsequent re-flood at a large barn conversion.

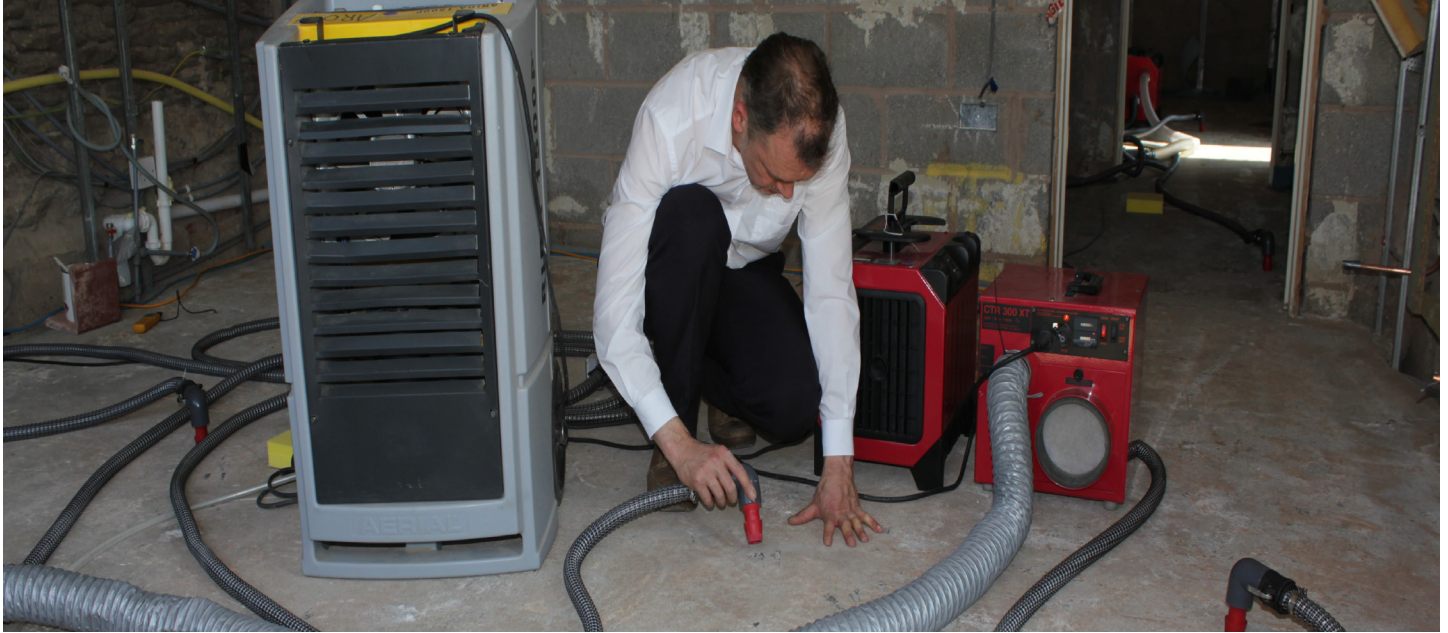
This drying technique is designed to pump warm dry air directly into the insulation layer in order to dry it out. This is a very effective drying method that required the drilling of approximately 40, 28mm diameter holes through the thickness of the screed. Overlying the insulation layer and then through the thickness of the insulation itself, whilst avoiding the densely packed water filled, plastic underfloor heating pipes.

Rainbow used a thermal imaging camera to plot the exact location of the holes between the underfloor heating pipework. A desiccant based turbine drying system was then installed using a system of manifolds and injection pipes.
